SITE INVESTIGATION REPORT

FORT McCLELLAN, ALABAMA TASK ORDER 001 Contract Number DAAA15-91-D-0017

U.S. Army Environmental Center Installation Restoration Division Aberdeen Proving Ground, Maryland 21010-5401

August 31, 1993

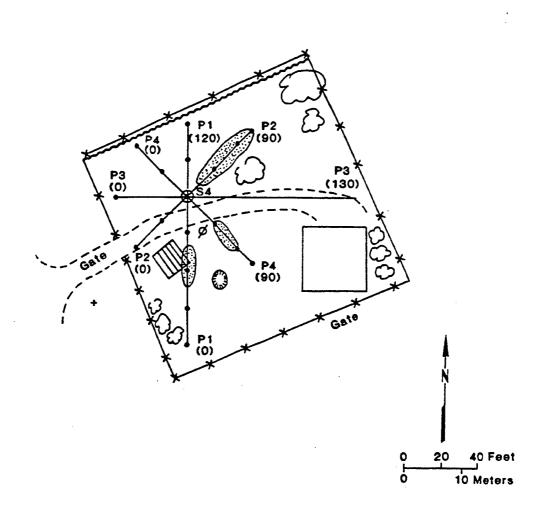
Figure 3-11

The location of transects and interpretation of EM data for sampling locations S3 and S4 at Area T-38 are shown in Figures 3-11 and 3-12, respectively. The profiles for sampling location S3 appear undisturbed. EM anomalies are present on P1 for sampling location S4 (Figure B-6, Appendix B) at 25 to 48 feet and may be related to a grandstand structure located in this area. Anomalies on P2 at 48 to 90 feet indicate ground disturbance in this area. Another in-phase anomaly (5 ppt) is present on P4 at 63 to 78 feet. The area at sampling location S4 appears undisturbed.

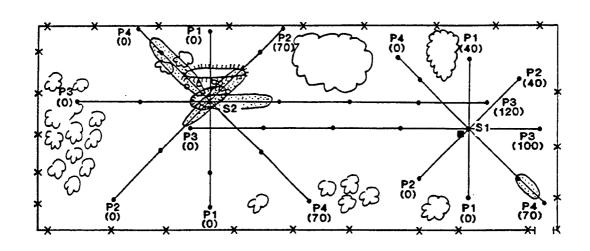
Figure 3-16

The locations of transects and interpretation of EM data for sampling locations S1 and S2 at Range J are shown in Figure 3-16. An in-phase anomaly (15 to 60 ppt) is present at P4 at 50 to 61 feet (Figure B-7, Appendix B). The remainder of the profiles for sampling location S1 appear undisturbed except near the edges, which is attributed to a fence. Several EM anomalies are observed for sample location S2. P2 is disturbed at 31 to 53 feet, P3 is disturbed at 36 to 58 feet, and P4 is disturbed at 7 to 27 feet.

Soil sampling and analysis at Range J did not detect the presence of HD or HD breakdown products at the sampled locations. Electromagnetic surveying in the vicinity of sample location 2 indicates a broad area of subsurface disturbance in the vicinity of the shallow burial pit at the site. A more extensive geophysical survey consisting of electromagnetics and magnetometry is recommended for Range J to delineate areas of subsurface disturbance.

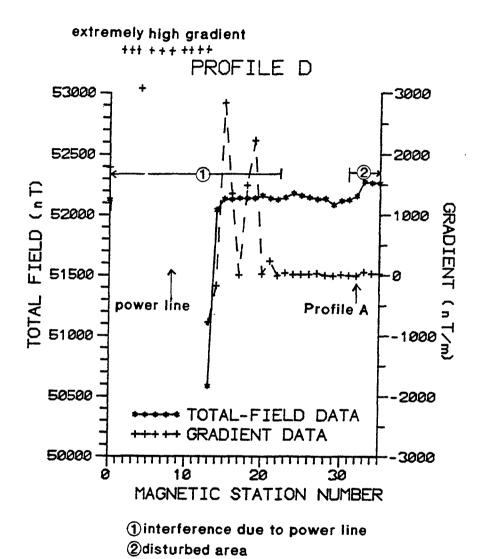
Profile D — Figure 3-25 depicts the magnetic data for Profile D. The beginning of this profile, stations 1 through 20, is disturbed due to the presence of the power line that crosses this profile at station 8. The small-scale total-field magnetic anomaly at stations 32 though 35 may be related to cultural effects associated with the nearby officers quarters.

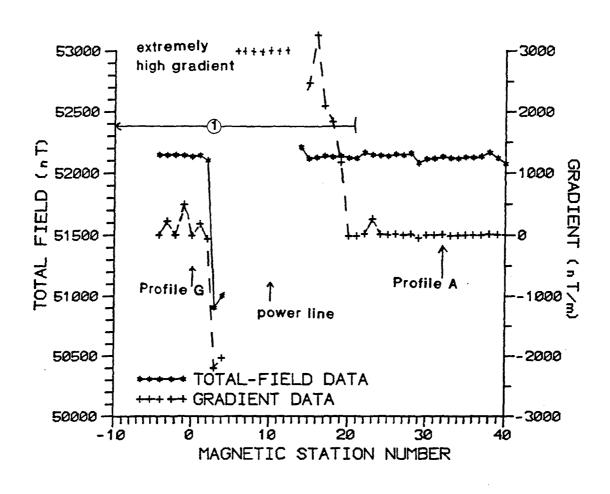
Figure 3-25

1 interference due to power line
